IT IS IMPORTANT TO CHECK CABLE ROUTING
PRIOR TO ASSEMBLING AND OPERATING LIFT

BOTH CABLES THAT RUN TO EACH
CROSSMEMBER ON THE NON PUMP SIDE MUST
RUN ALONG THE BOTTOM PULLEYS

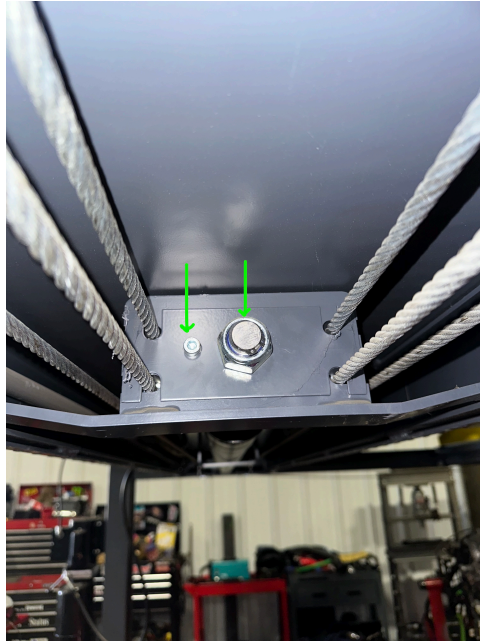
- REMOVE SMALL ALLEN BOLT AND CYLINDER NUT TO REMOVE THE CABLE GUIDE PLATE

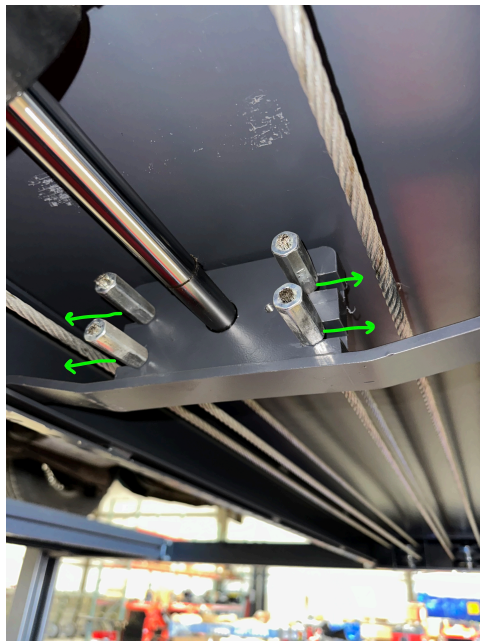
- SLIDE EACH CABLE OUT FROM THE CYLINDER RAM PLATE

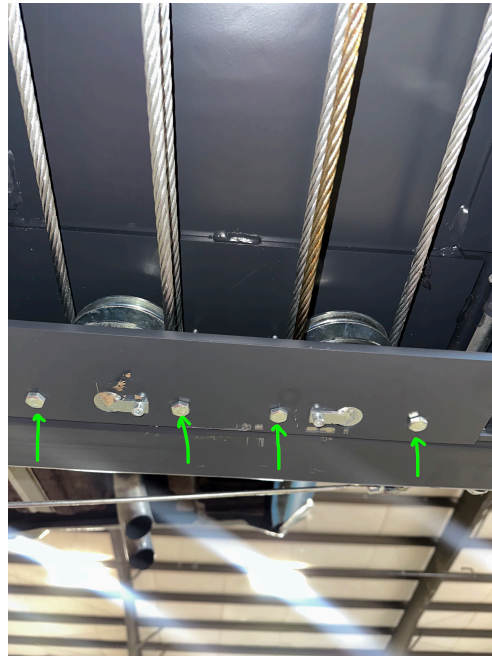
- REMOVE 4 HEX BOLTS

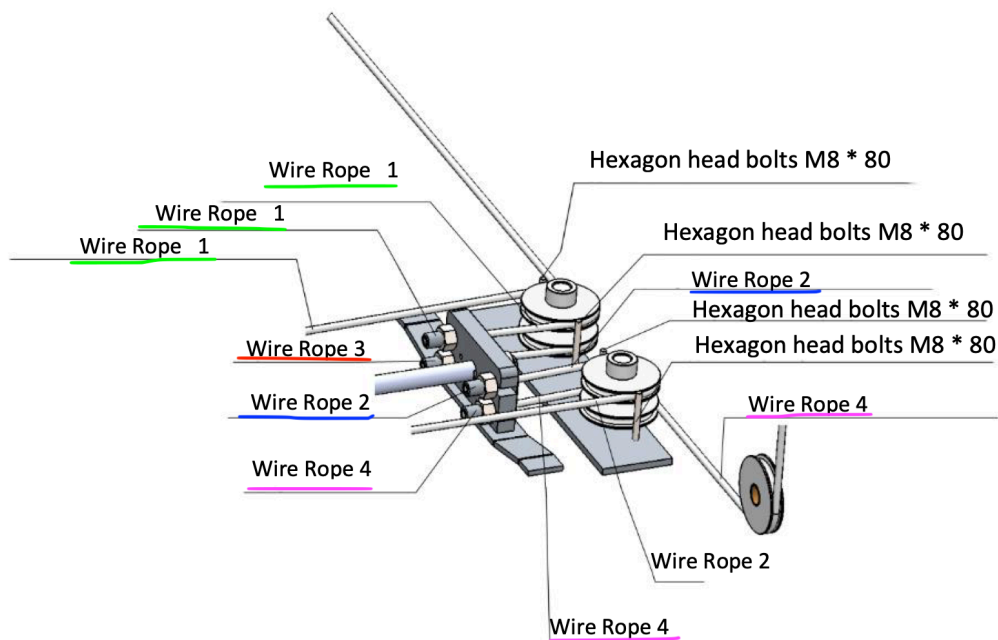
(See Fig. 21)

- REMOVE CABLES AND RE-INSTALL ALONG THE CORRECT PULLEYS
- PLEASE NOTE CABLE #4 and #2 RUN ALONG THE BOTTOM PULLEYS
- RE-INSTALL HARDWARE IN REVERSE ORDER
